DEPARTMENT OF TRANSPORTATION**DIVISION OF ENGINEERING SERVICES**

Quality Assurance and Source Inspection

Contract #: 04-0120F4Cty: SF/ALA Rte: 80 PM: 13.2/13.9File #: 1x.28**WELDING INSPECTION REPORT****Resident Engineer:** Casey, William**Address:** 333 Burma Road**City:** Oakland, CA 94607**Report No:** WIR-026804**Date Inspected:** 02-Dec-2011**Project Name:** SAS Superstructure**OSM Arrival Time:** 630**Prime Contractor:** American Bridge/Fluor Enterprises, a JV**OSM Departure Time:** 1530**Contractor:** American Bridge/Fluor Enterprises, a JV**Location:** Jobsite**CWI Name:** Bernie Docena**CWI Present:** Yes No**Inspected CWI report:** Yes No N/A**Rod Oven in Use:** Yes No N/A**Electrode to specification:** Yes No N/A**Weld Procedures Followed:** Yes No N/A**Qualified Welders:** Yes No N/A**Verified Joint Fit-up:** Yes No N/A**Approved Drawings:** Yes No N/A**Approved WPS:** Yes No N/A**Delayed / Cancelled:** Yes No N/A**Bridge No:** 34-0006**Component:** Bike Path - Skyway**Summary of Items Observed:**

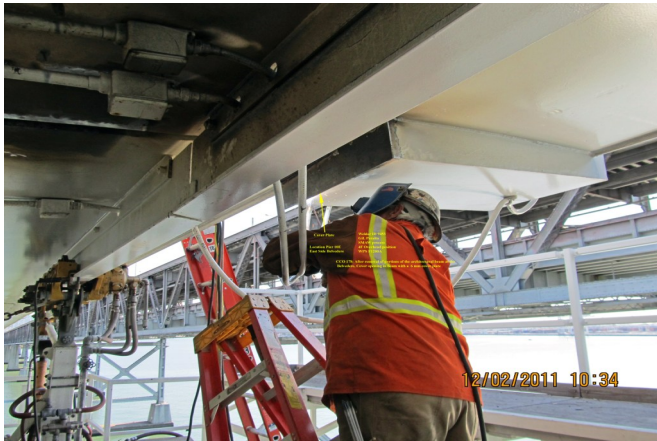
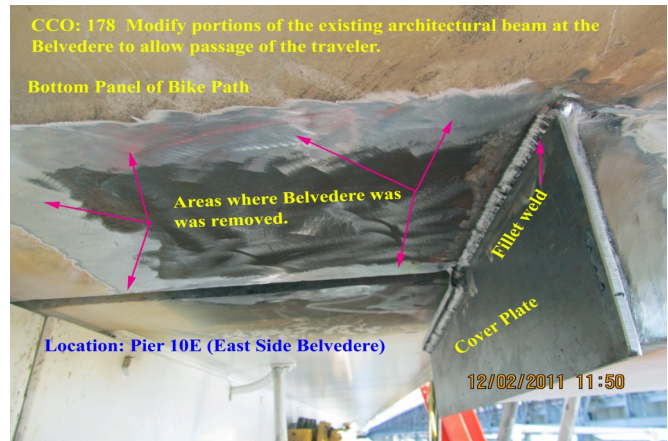
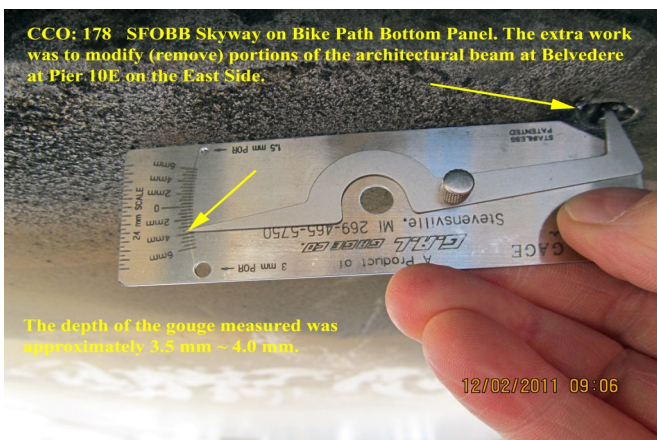
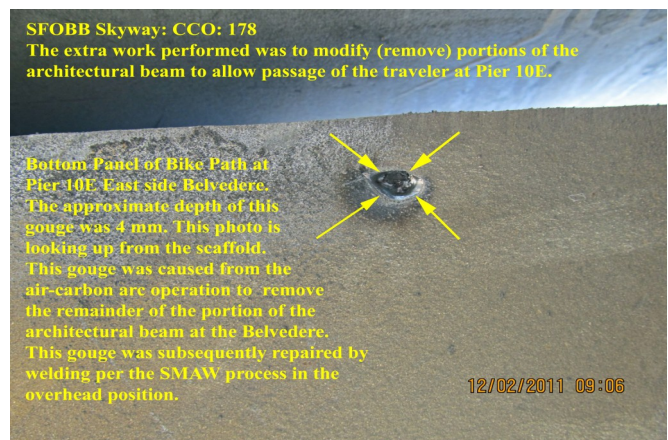
This QA Inspector randomly observed ABF welder Mr. Gil Peralta performing the Air-Carbon-Arc gouge operation to remove the remnant material - (at least 10 mm of material) of the section of the architectural beam that was previously removed by others from the bottom panel of the Bike Path at Pier Location 10E - (east side location). This QA Inspector observed that there was one (1) area on the bottom panels' base metal that was gouged into from the Air-Carbon-Arc gouge operation that required weld repair from the removal of the portion of the architectural beam. After the base metal was repaired per the SMAW process in the overhead position by ABF Welder Gil Peralta (Welder ID 9543), the repaired area was ground flush and smooth to the base metal surface.

Afterwards, this QA Inspector randomly observed ABF welder Mr. Gil Peralta (Welder ID 9543) performing the fillet weld operation on the six (6) mm thick cover plate to cover the opening in the architectural beam of the belvedere at Pier Location 10E per the Shielded Metal Arc Welding (SMAW) process in the (3F) vertical and (4F) overhead positions.

that the preheat temperature of 70 degrees F was established and afterwards verified that the welding parameters (Amps, Volts and Travel Speed) were in accordance with WPS-F1200A. After the fillet weld operation was completed connecting the cover plate to the end of the opening in the architectural beam, this QA Inspector observed QC Inspector Mr. Bernie Docena; perform a visual inspection of the fillet weld to verify the fillet weld size and weld quality. The fillet weld size and quality visually appeared to be in general compliance with AWS D1.5-2002 Section 3.6 and 6.26.

This QA Inspector also witnessed the magnetic particle inspection on 100% of the length of weld connecting the cover plate to the opening in the architectural beam using the yoke method in conformance with ASTM E709 and the standard of acceptance in conformance with AWS D1.5-2002 Section 6.26.

This QA Inspector also observed ABF personnel performing the drilling operation for the installation of additional mounting bolts - (19 mm diameter) thru the existing box girder web plate of the Bike path box girder and thru the Bike Path maintenance traveler outer rail. This QA Inspector observed that the ABF personnel were in-process on the drilling operation and were working towards Pier location 10E by the end of this QA Inspectors' shift.
